## FIRST ADDENDUM TO DISCLOSURE STATEMENT

## Pre-Existing Elements Fund Study 292 Main Street - Toronto

Final Report

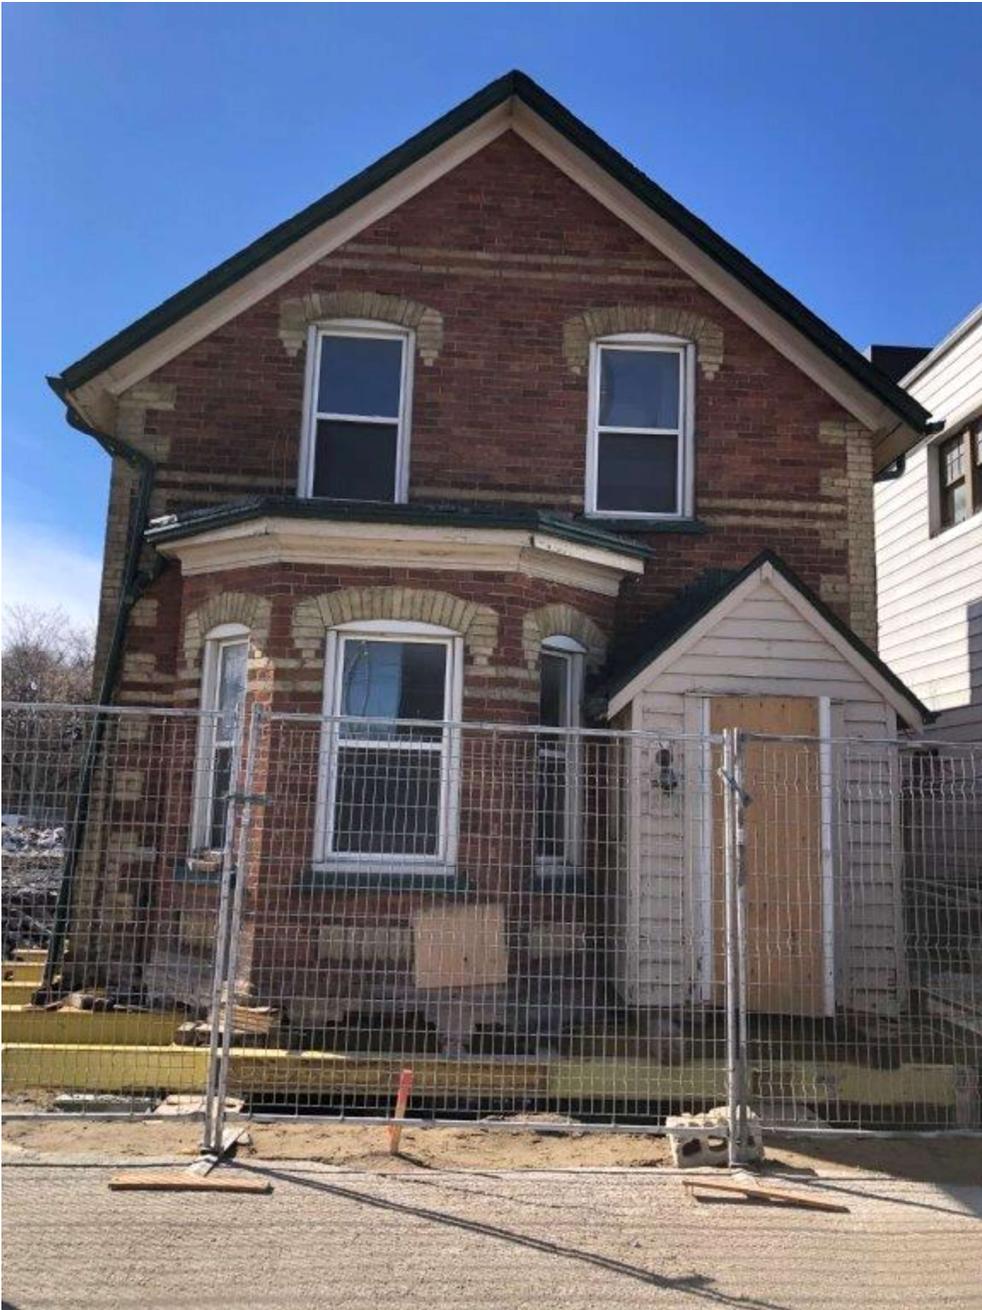
East Elevation Photograph

- 100% cleaning and repointing of masonry and selective brick replacement;
- Tuckpointing (brickwash and ribbon);
- Full replacement of window units with new wood to match original design;
- Replacement of existing window sill with new stone sills.
- Removal of front entrance addition;
- New asphalt shingle roof;
- Repair existing woodwork (gables and soffits/decorative trim);
- Repair existing metal work (cresting on bay, new downspouts, new flashing); and
- Replacement of main door.

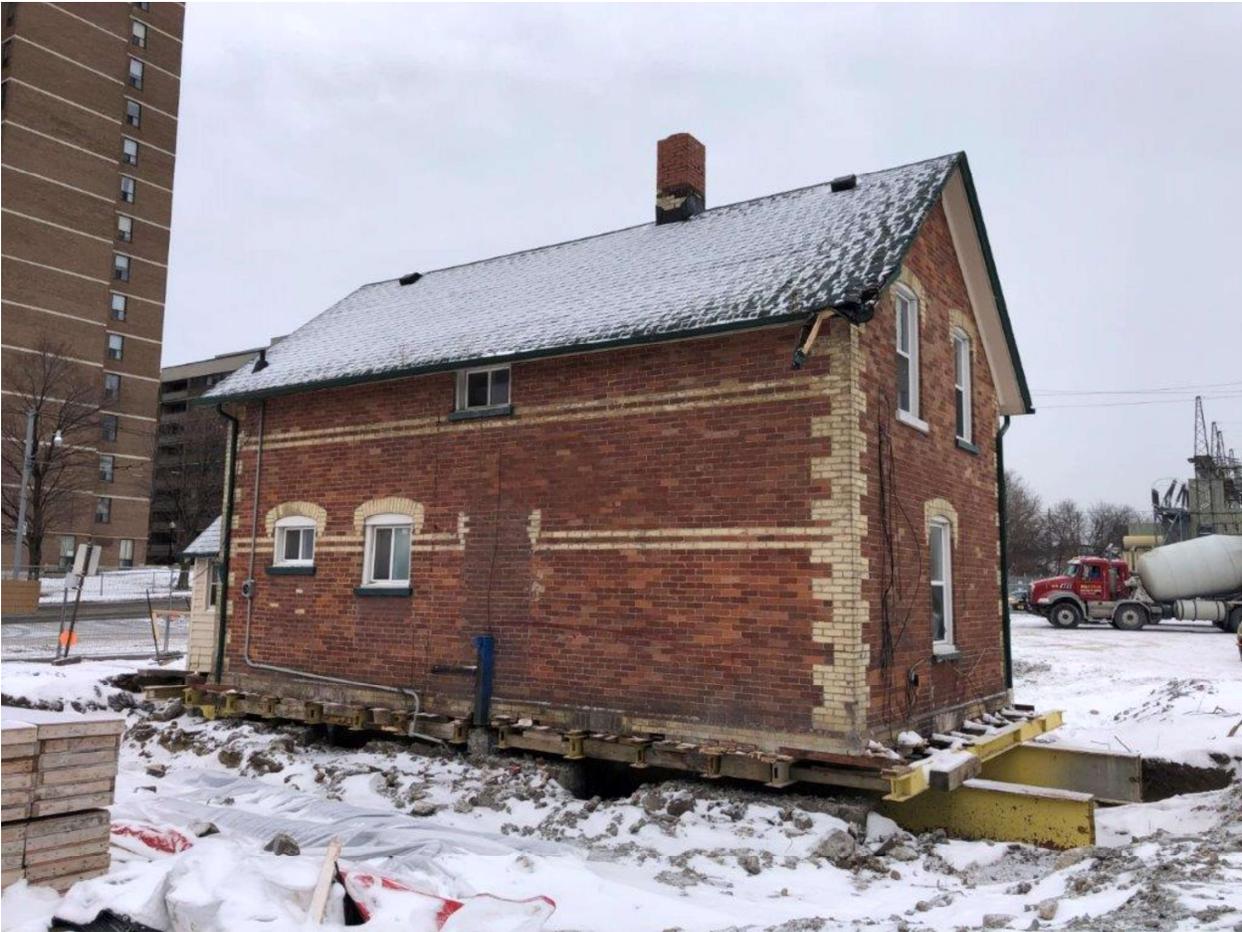
North Elevation Photograph

- 100% cleaning and repointing of masonry and selective brick replacement;
- Removal of existing windows and infill with recessed brick to match layout of window openings;
- Replacement of existing window sill with new stone sills.
- Removal of existing basement entrance;
- Repair existing woodwork (gables and soffits); and
- Replace existing metal work (new downspouts, new flashing).

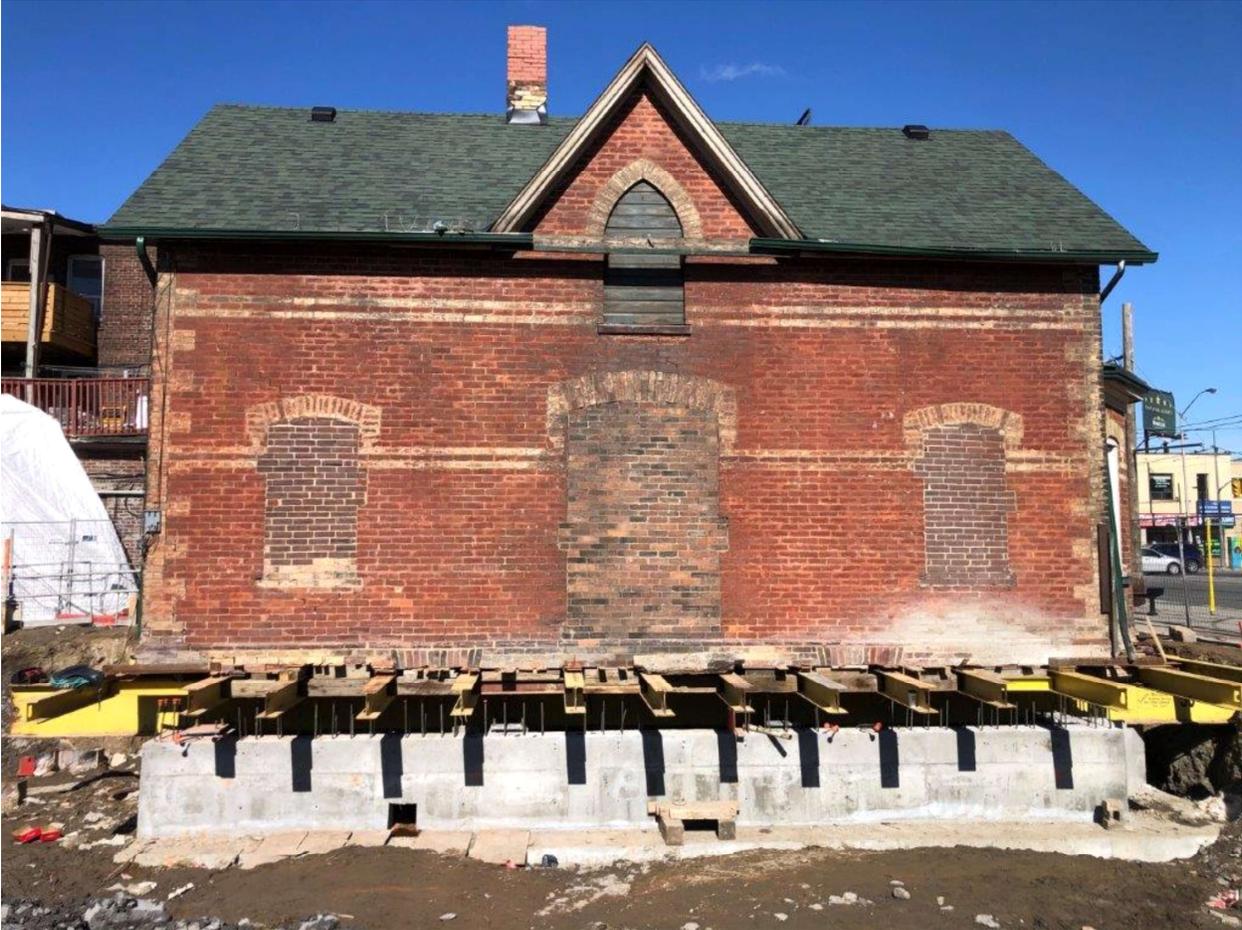
South Elevation Photograph

- 100% cleaning and repointing of masonry and selective brick replacement;
- Removal of existing vinyl windows and infill with recessed brick to match layout of existing openings;
- Replacement of existing window sill with new stone sills.
- Repair existing woodwork (soffits); and
- Replace existing metal work (new flashing).

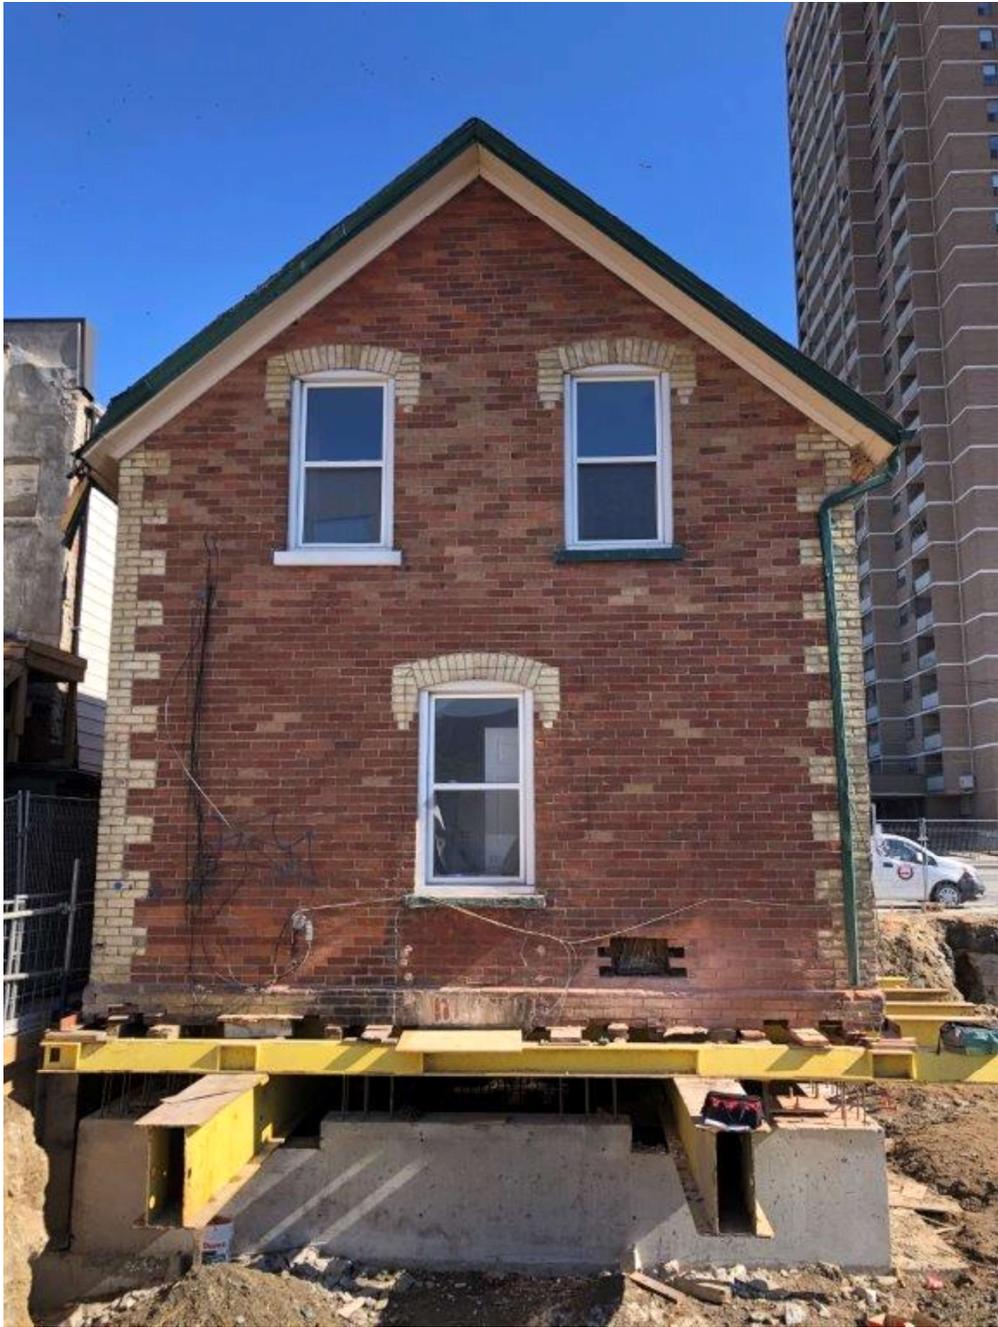
West Elevation Photograph

- 100% cleaning and repointing of masonry and selective brick replacement;
- Repair existing woodwork (soffits);
- Repair existing metal work (new flashing, repair louvre);
- Remove infill materials from lancet and easternmost window openings and replace with new wood units to match original design; and
- Replacement of existing window sill with new stone sills.

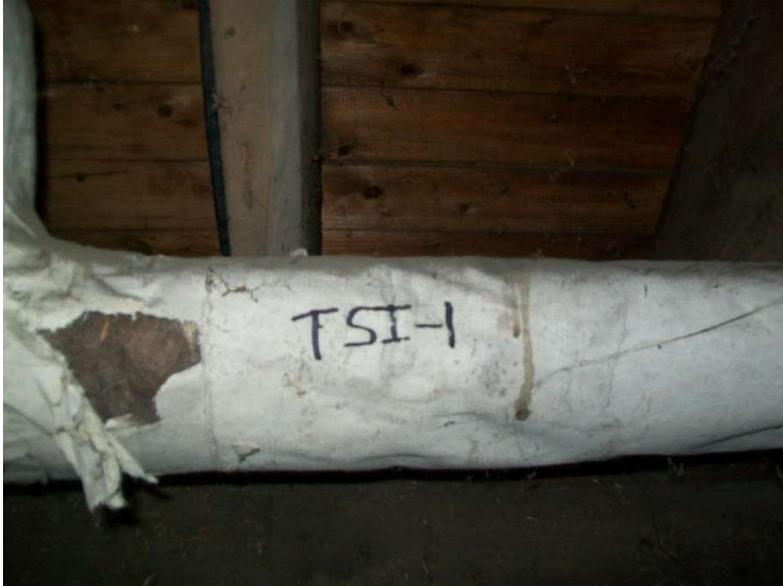
**PHOTOGRAPH 1: ACM pipe insulation located in basement of 290 Main Street.**

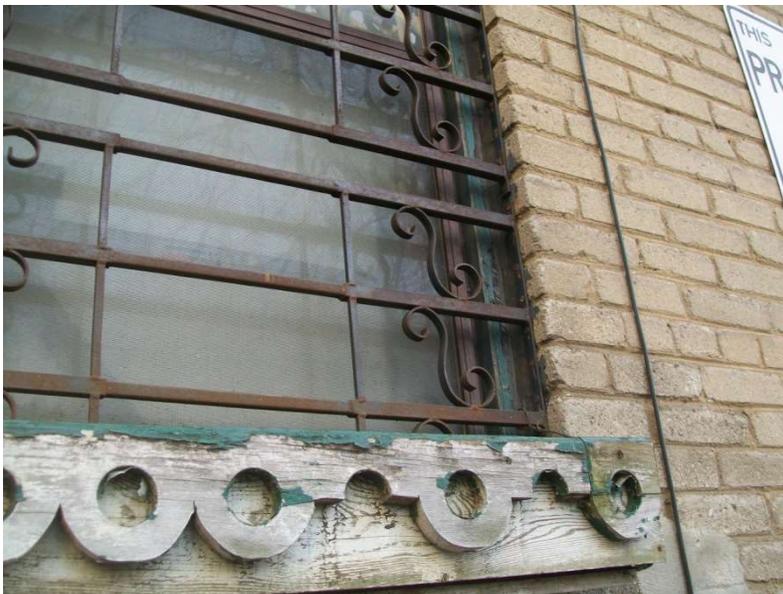
**PHOTOGRAPH 2: ACM window caulking at 290 Main Street.**

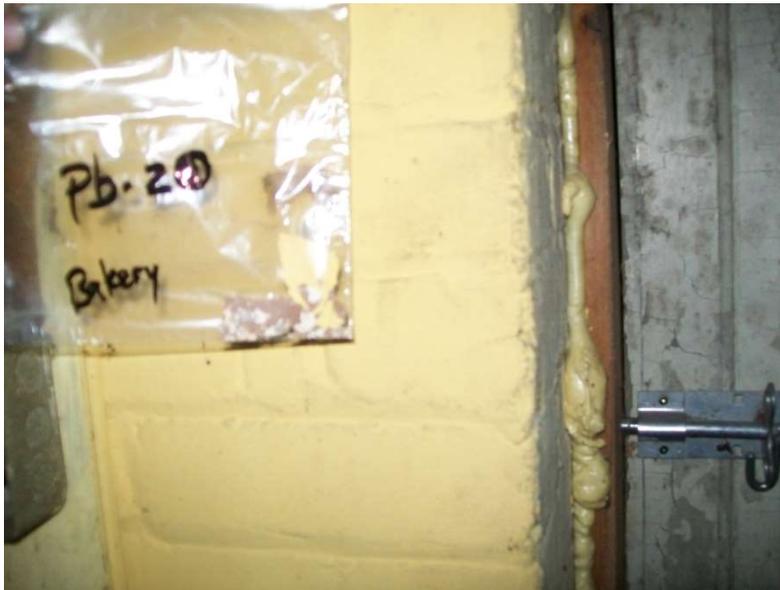
**PHOTOGRAPH 3:** Lead-containing paint (yellow) located in basement of 290 Main Street.

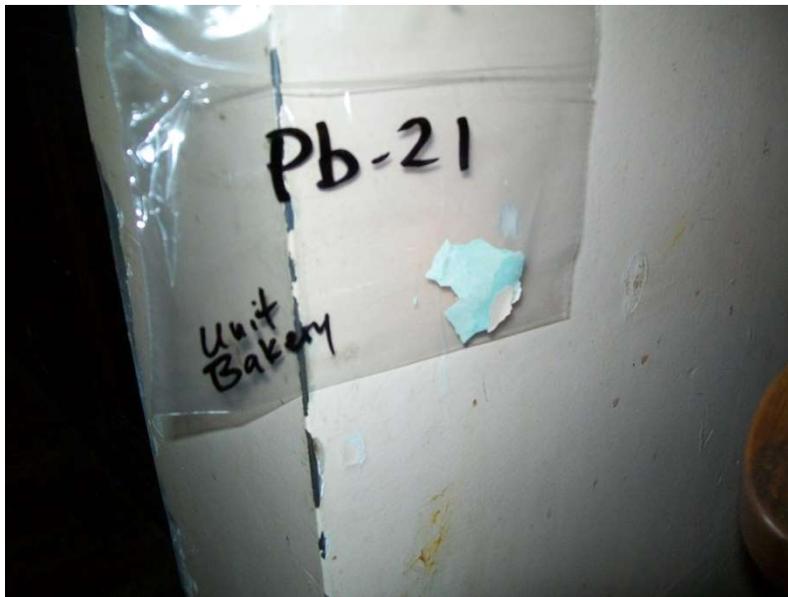
**PHOTOGRAPH 4:** Lead-containing paint (beige over blue) in the 1<sup>st</sup> floor main room at 290 Main Street.

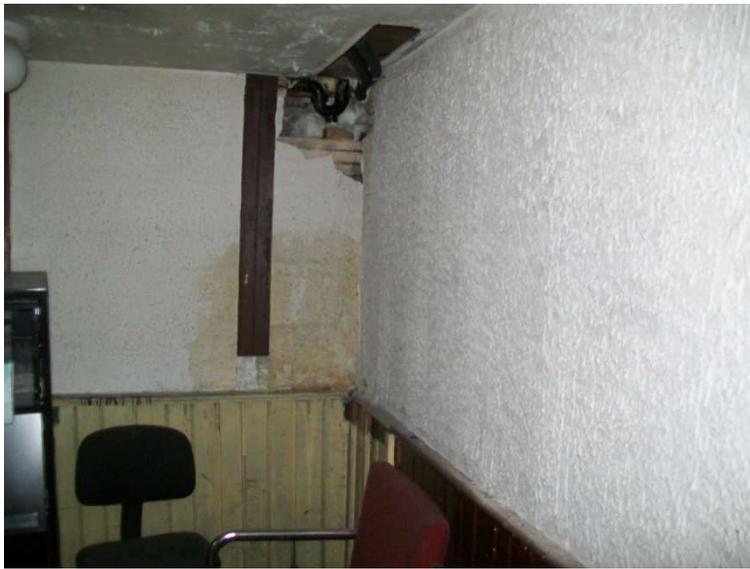
**PHOTOGRAPH 5: ACM stucco coating on walls in basement of 292 Main Street.**

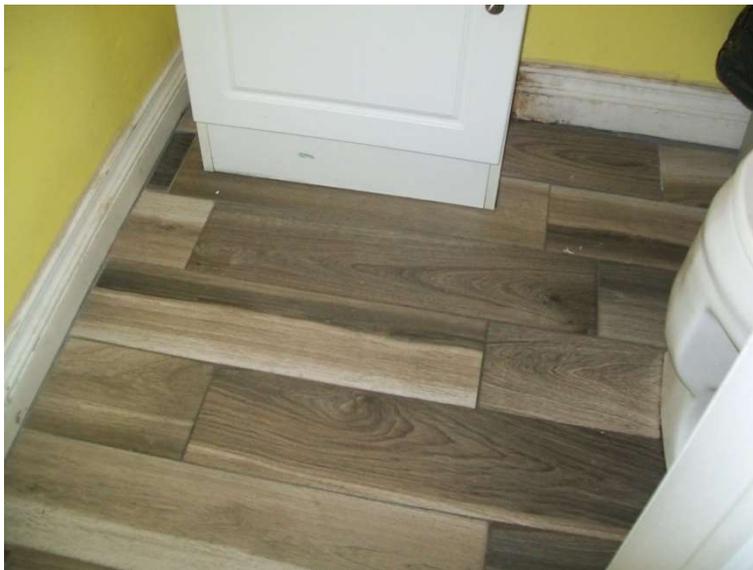
**PHOTOGRAPH 6: Lead-containing paint (yellow) in the 1<sup>st</sup> floor washroom at 292 Main Street.**

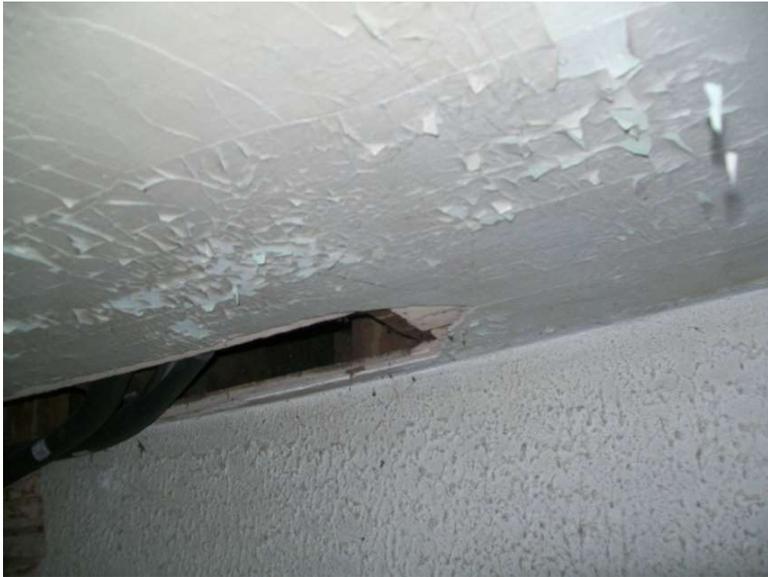
**PHOTOGRAPH 7: Lead-containing paint located in the main room of the basement at 292 Main Street.**

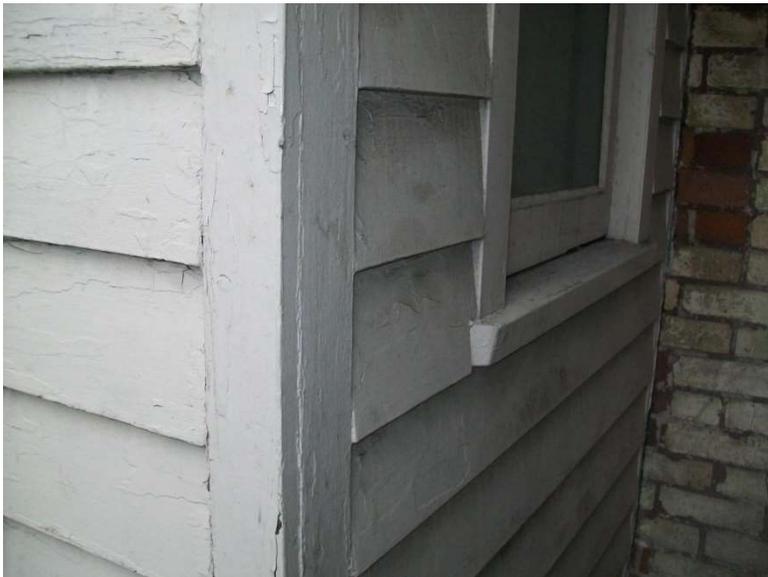
**PHOTOGRAPH 8: Lead-containing paint (beige) on the exterior of 292 Main Street.**

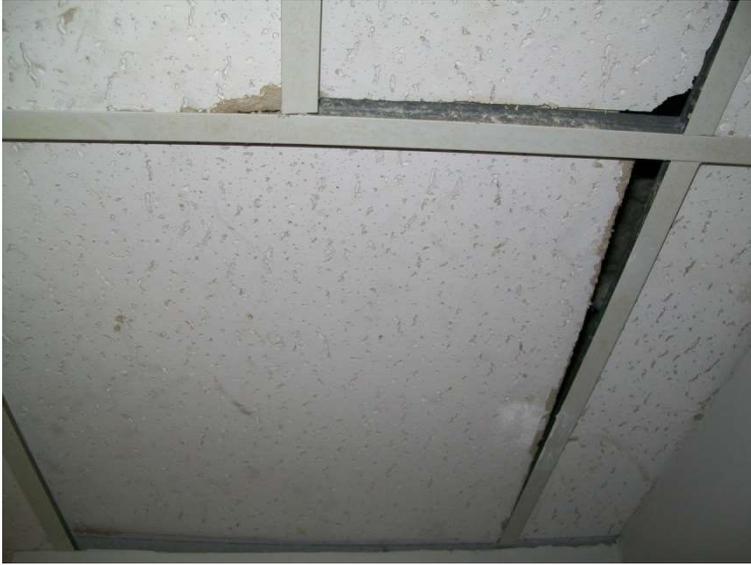
**PHOTOGRAPH 9: ACM ceiling tiles located in 294 Main Street, in the basement utility room, Suite 301, Suite 501b and in the vacant (un-numbered) suite on the 5<sup>th</sup> floor.**

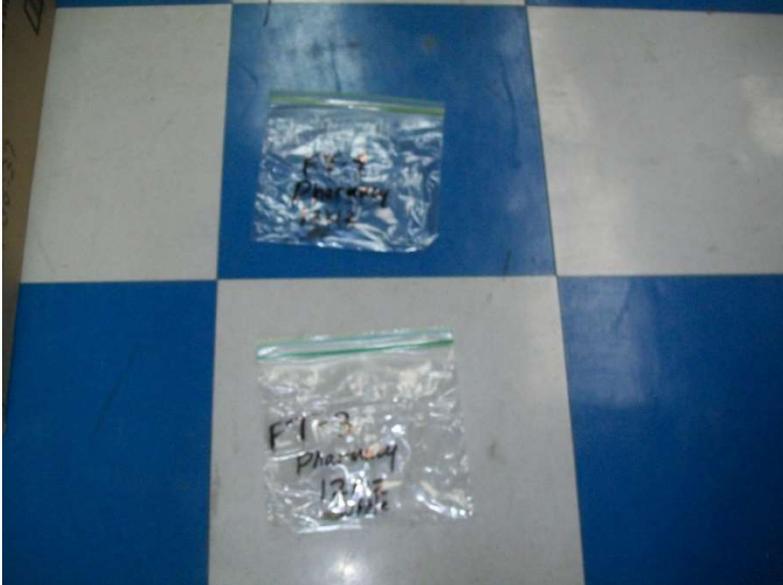
**PHOTOGRAPH 10: ACM vinyl floor tiles located in Suite 102 at 294 Main Street. The blue tiles do not contain asbestos.**

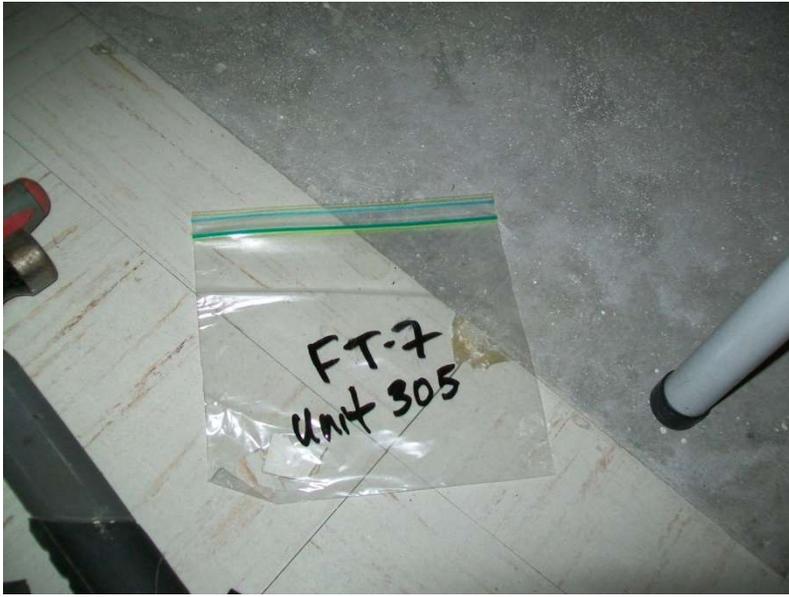
**PHOTOGRAPH 11: ACM vinyl floor tiles located in Suite 305 of 294 Main Street.**

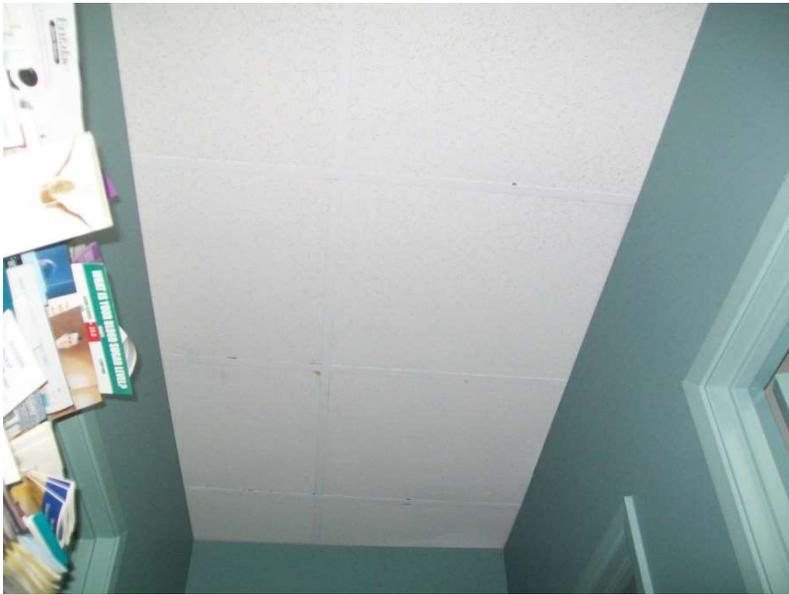
**PHOTOGRAPH 12: Lead-containing paint (light blue) located in Suite 507 at 294 Main Street.**

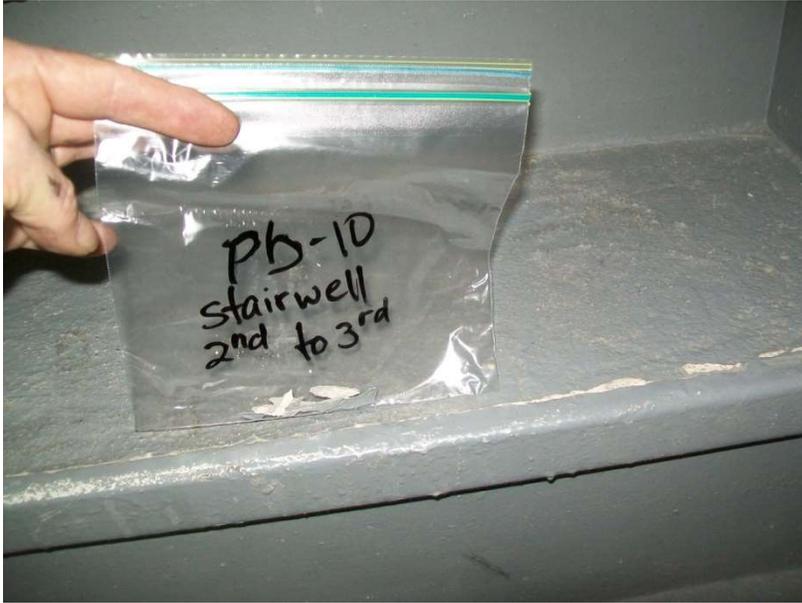
**PHOTOGRAPH 13:** Lead-containing paint located in the 3<sup>rd</sup> floor stairwell at 294 Main Street.
