## FIRST ADDENDUM TO DISCLOSURE STATEMENT

## Pre-Existing Elements Fund Study 292 Main Street - Toronto

Final Report

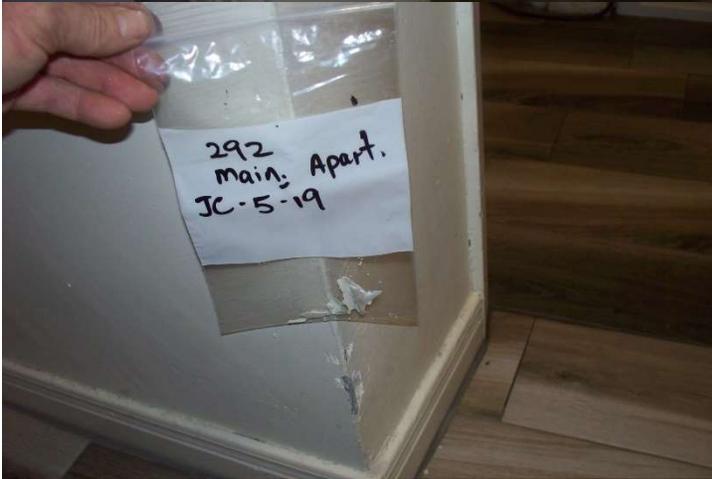
Photograph 16

Sample ID: JC-5-19

Location: 292 Main Street, 2<sup>nd</sup> floor apartment

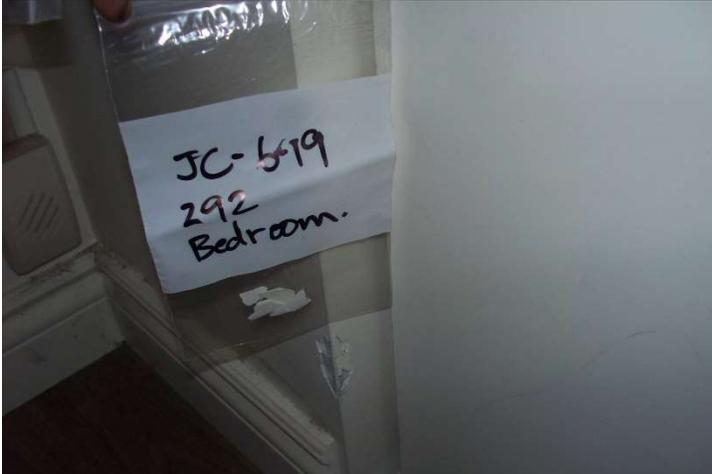
Photograph 17

Sample ID: JC-6-19

Location: 292 Main Street, 2<sup>nd</sup> floor bedroom

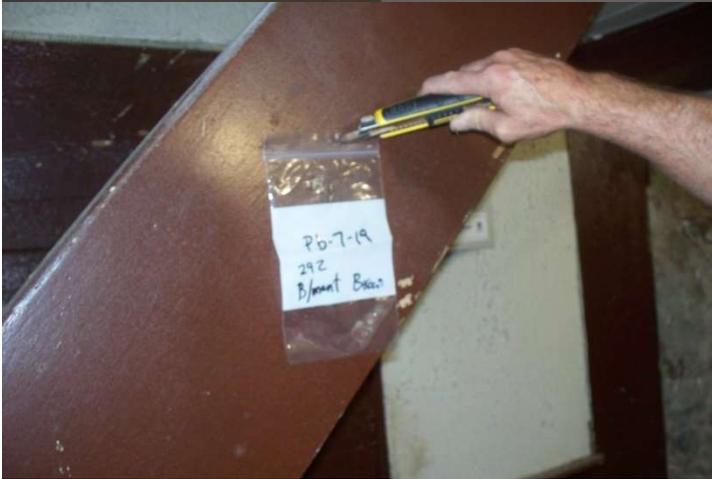
Photograph 19

Sample ID: Pb-7-19

Location: 292 Main Street, basement stairs

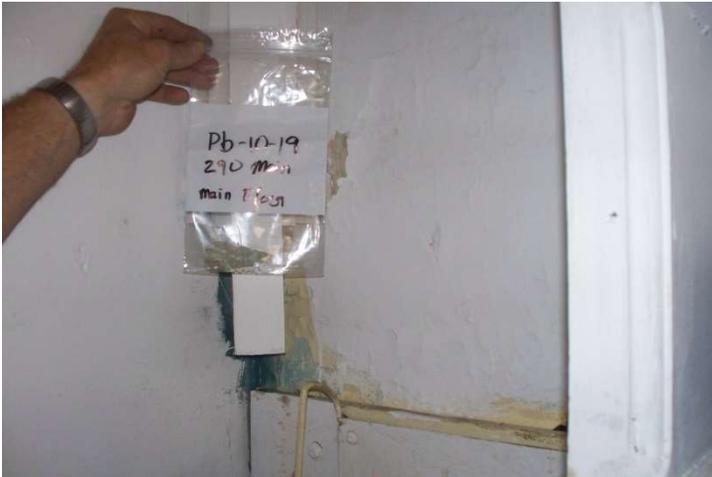
Photograph 21

Sample ID: Pb-10-19

Location: 288 - 290 Main Street, 1<sup>st</sup>  
floor

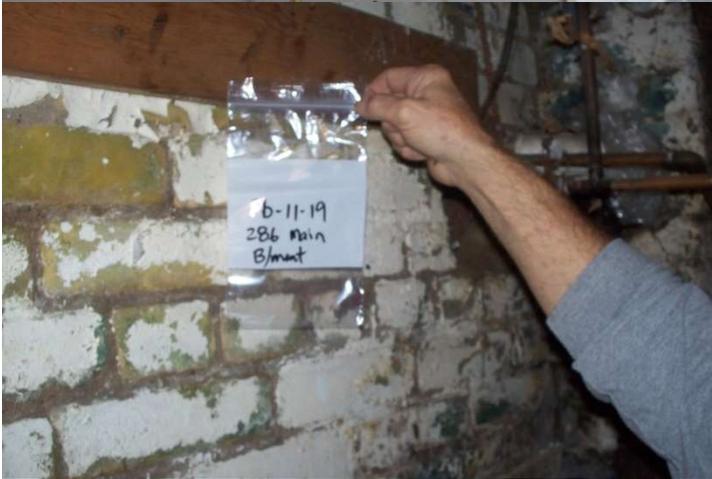
Photograph 22

Sample ID: Pb-11-19

Location: 286 Main Street, basement

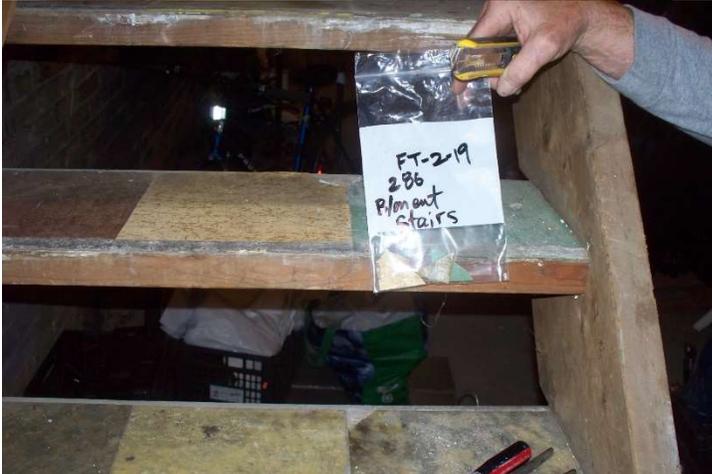
Photograph 23

Sample ID: FT-2-19

Location: 286 Main Street, basement  
stairs

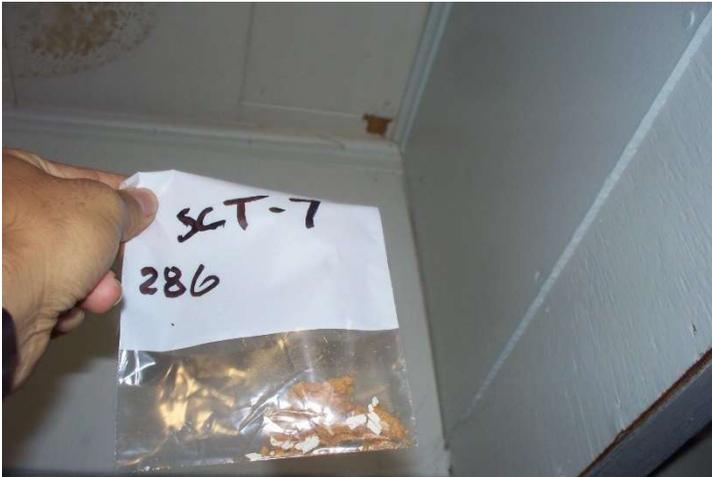
Photograph 24

Sample ID: SCT-7-19

Location: 286 Main Street, ceiling

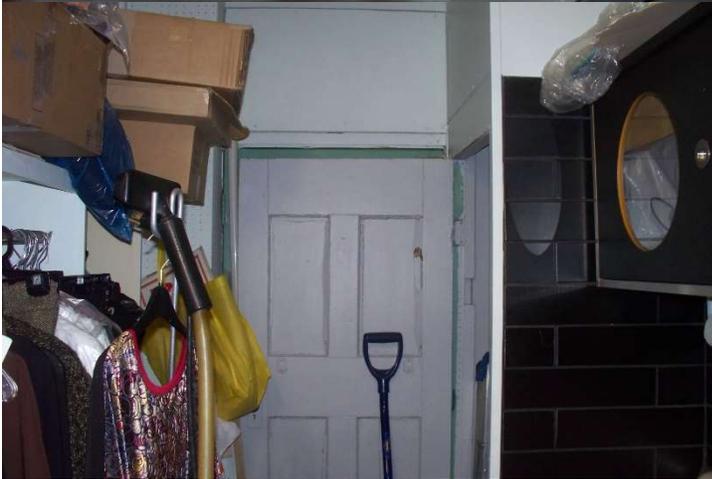
Photograph 24

Sample ID: Pb-12-19

Location: 286 Main Street, bathroom door

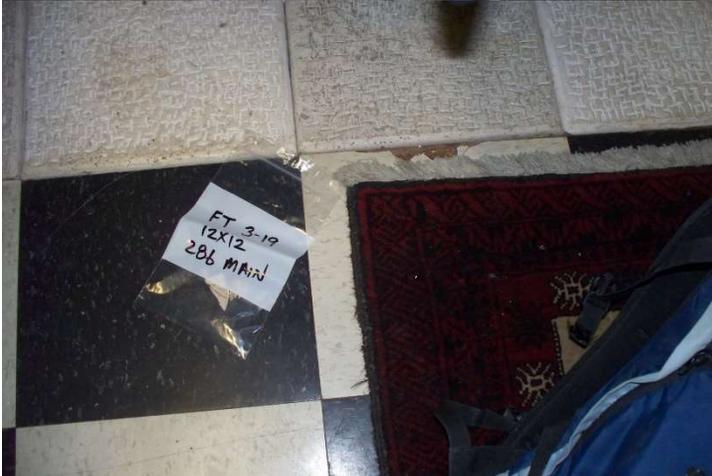
Photograph 25

Sample ID: FT-3-19

Location: 286 Main Street, floor

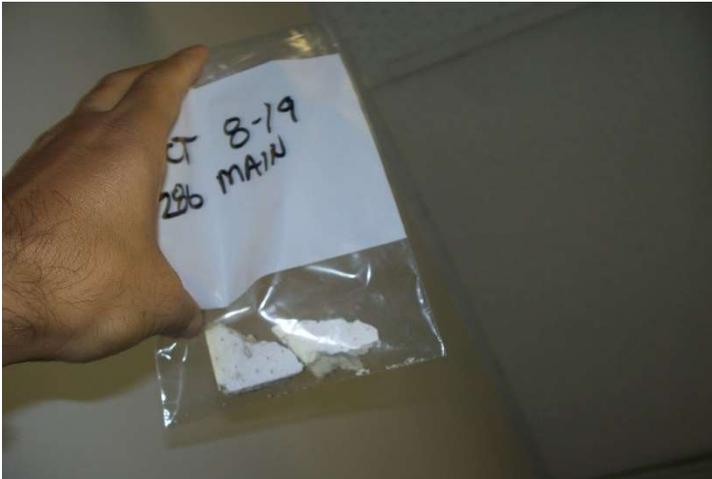
Photograph 26

Sample ID: SCT-8-19

Location: 286 Main Street, ceiling

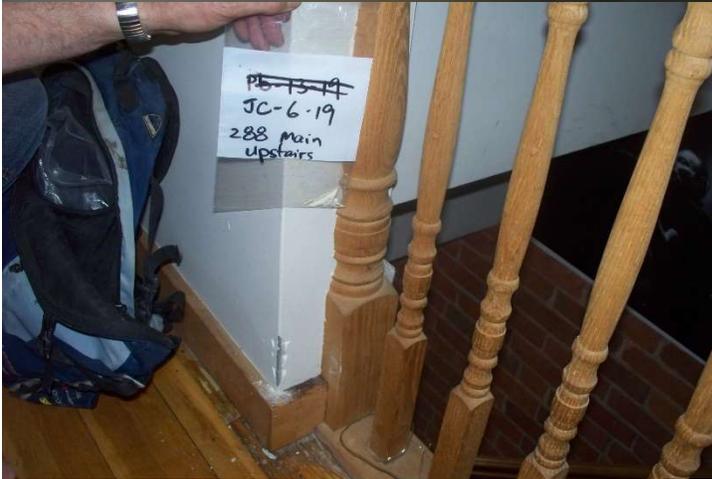
Photograph 27

Sample ID: JC-6-19

Location: 288-290 Main Street, 2<sup>nd</sup> floor

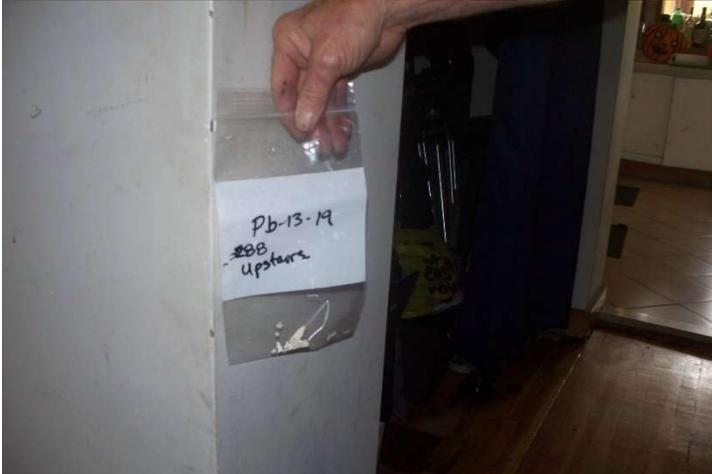
Photograph 28

Sample ID: Pb-13-19

Location: 288-290 Main Street, 2<sup>nd</sup> floor

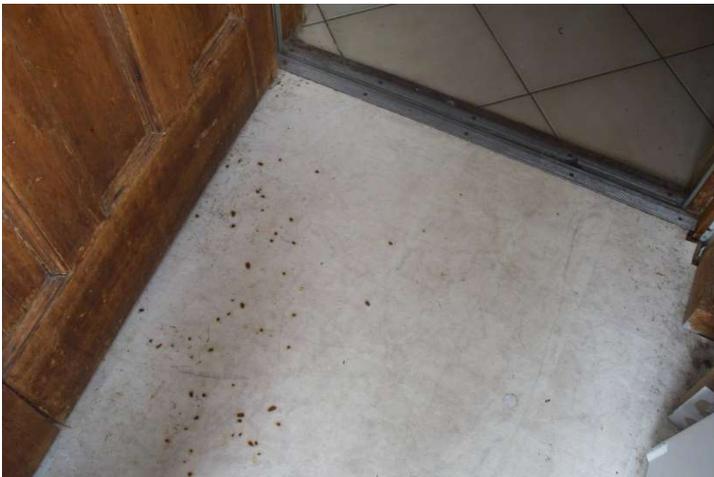
Photograph 29

Sample ID: FT-4-19

Location: 288-290 Main Street, 2<sup>nd</sup> floor  
hall

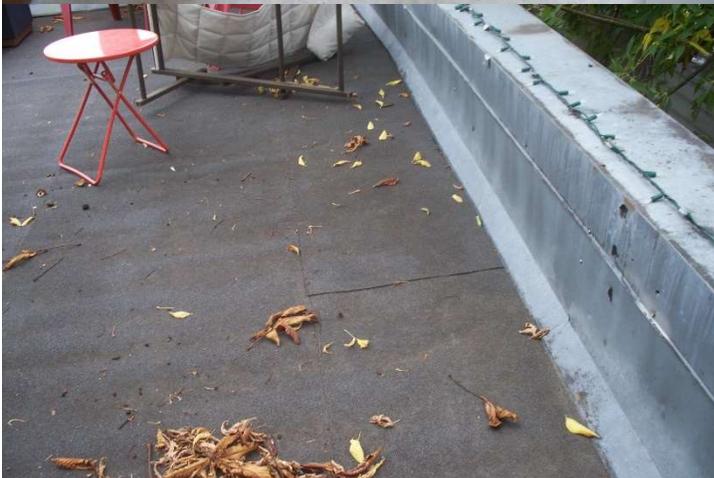
Photograph 30

Sample ID: ASB-3-19

Location: 288-290 Main Street, roof  
patio

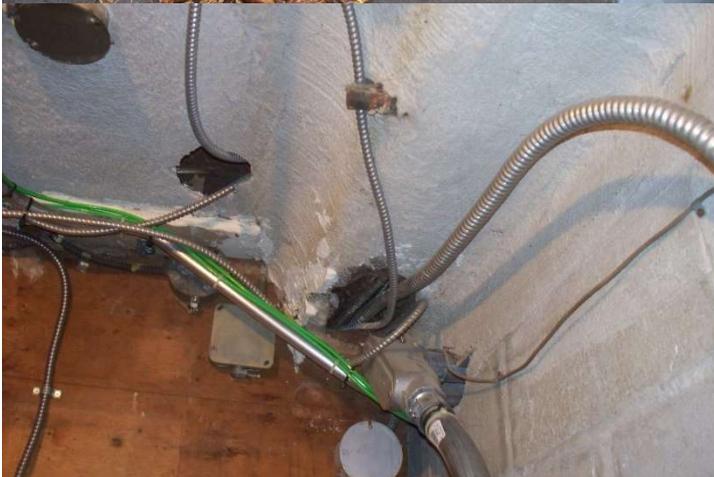
Photograph 31

Sample ID: ASB-4-19

Location: 276 Main Street, electrical  
room ceiling

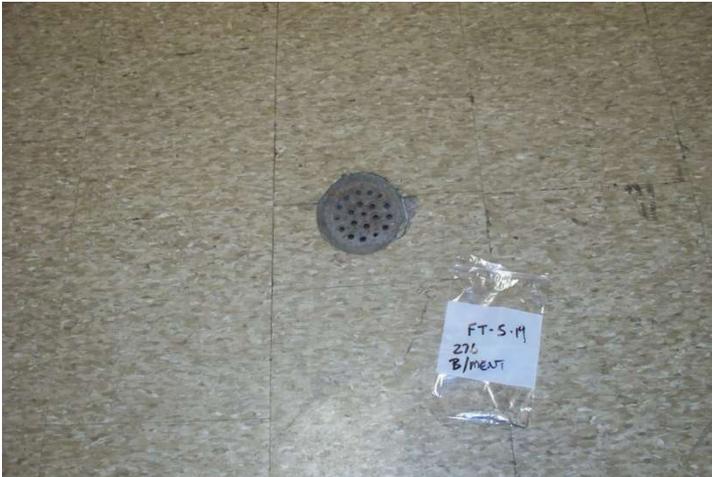
Photograph 32

Sample ID: FT-5-19

Location: 276 Main Street, east side of basement

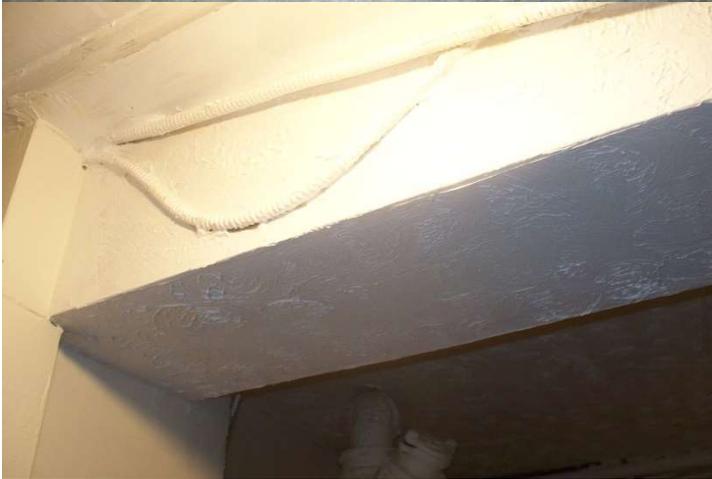
Photograph 33

Sample ID: ASB-5-19

Location: 276 Main Street, basement ceiling

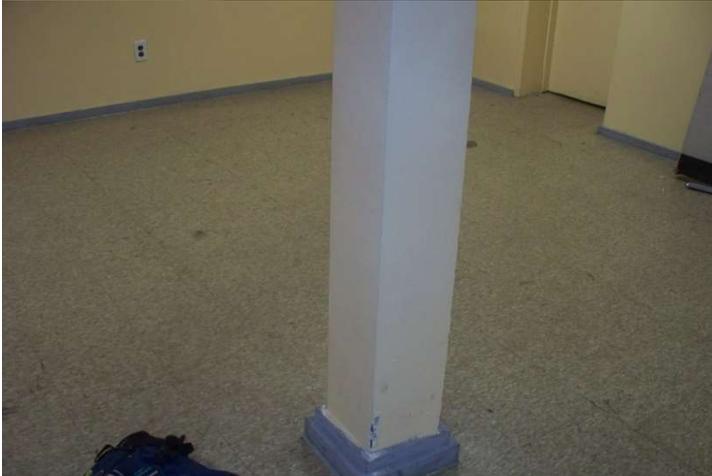
Photograph 34

Sample ID: JC-8-19

Location: 276 Main Street, basement columns

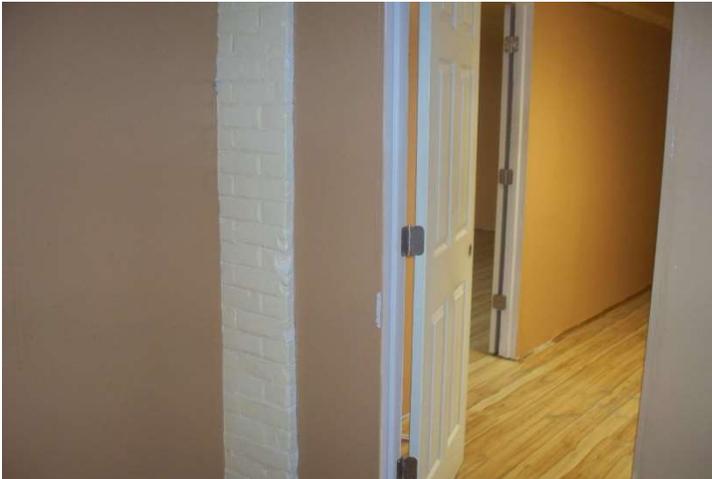
Photograph 35

Sample ID: Pb-16-19

Location: 276 Main Street, basement walls

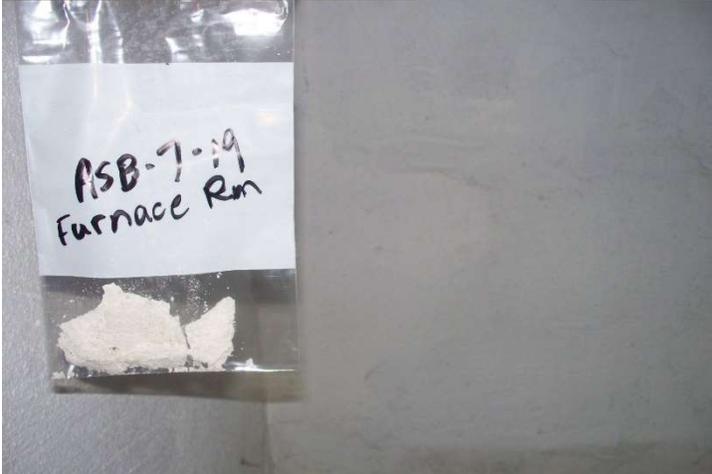
Photograph 37

Sample ID: ASB-7-19

Location: 276 Main Street, furnace room

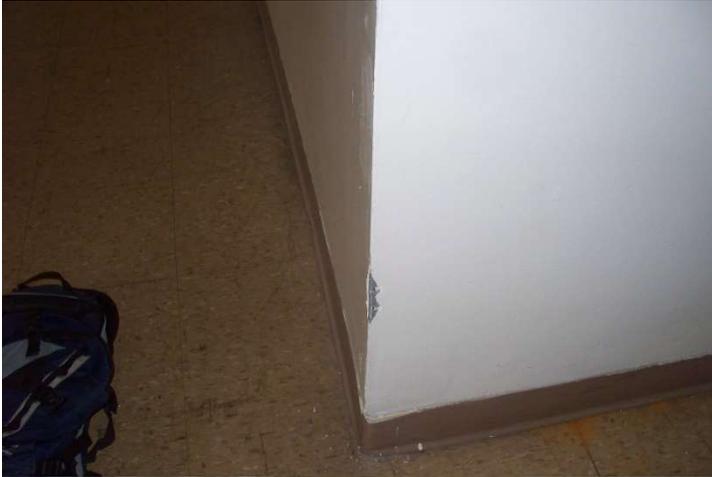
Photograph 41

Sample ID: JC-10-19

Location: 276 Main Street, 1<sup>st</sup> floor

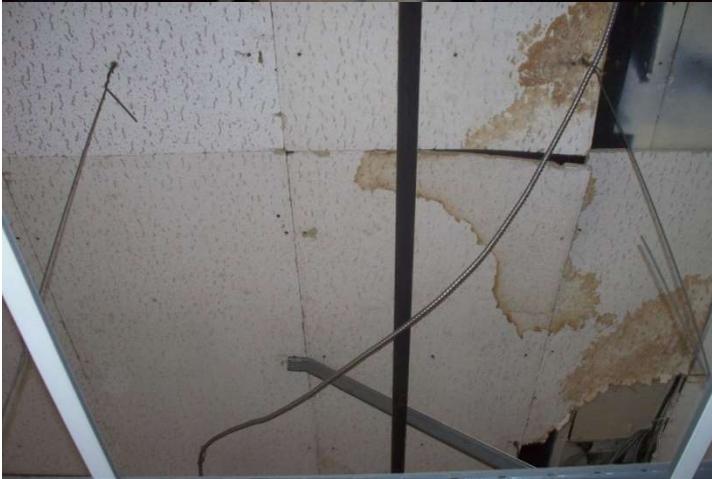
Photograph 45

Sample ID: SCT-9-19

Location: 276 Main Street, 1<sup>st</sup> floor

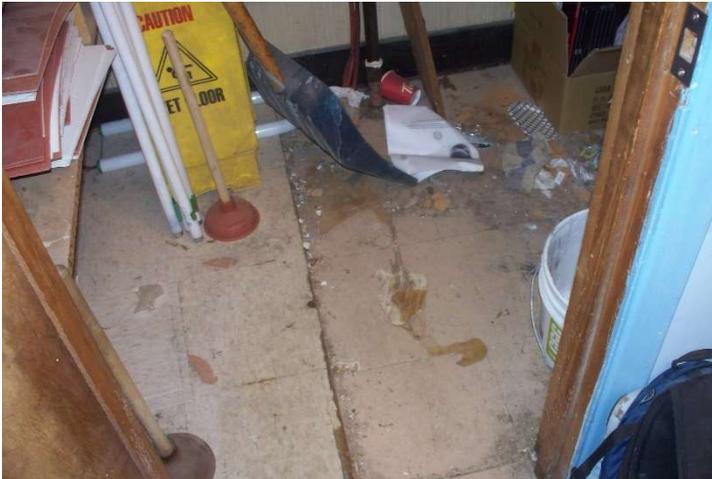
Photograph 47

Sample ID: FT-9-19

Location: 276 Main Street, 1<sup>st</sup> floor

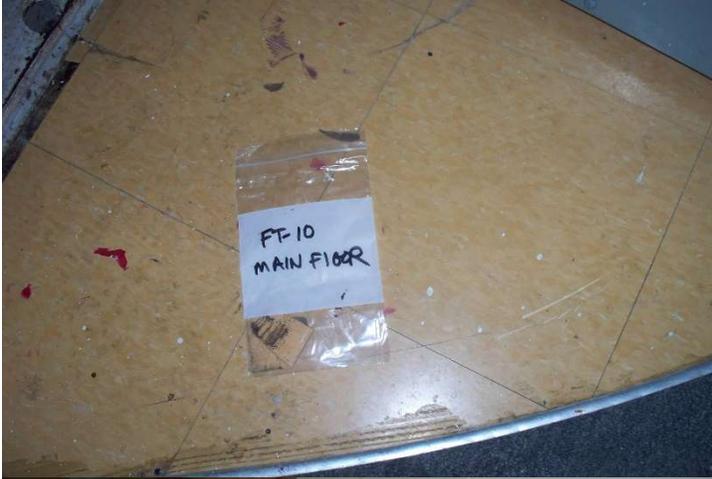
Photograph 48

Sample ID: FT-10-19

Location: 276 Main Street, 1<sup>st</sup> floor

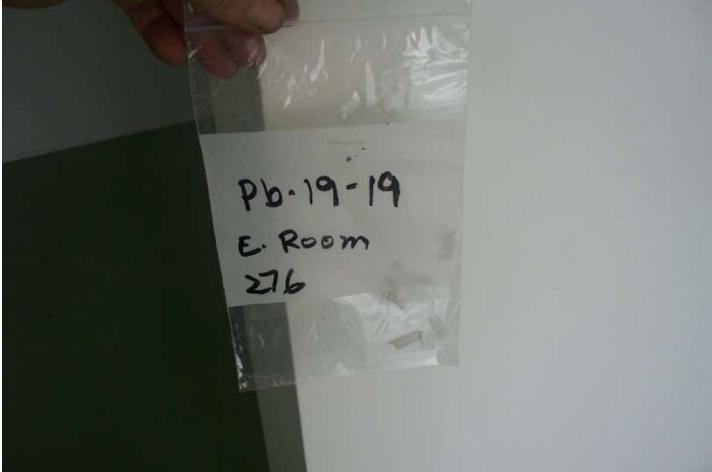
Photograph 49

Sample ID: Pb-19-19

Location: 276 Main Street, 1<sup>st</sup> floor, east room

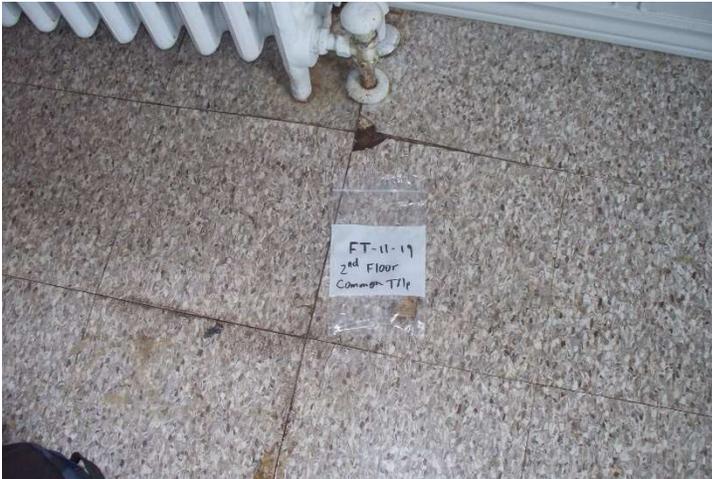
Photograph 49

Sample ID: FT-11-19

Location: 276 Main Street, 2<sup>nd</sup> floor

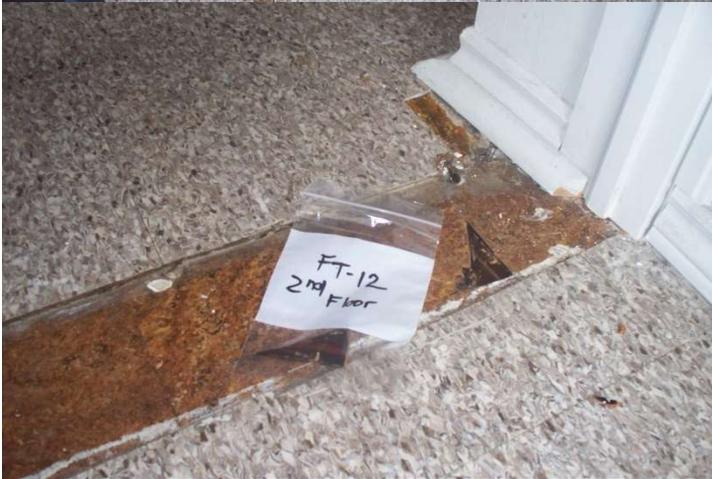
Photograph 50

Sample ID: FT-12-19

Location: 276 Main Street, 2<sup>nd</sup> floor

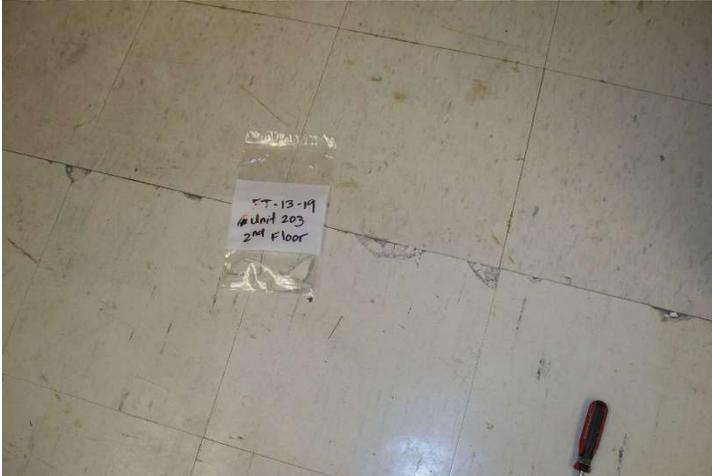
Photograph 51

Sample ID: FT-13-19

Location: 276 Main Street, 2<sup>nd</sup> floor

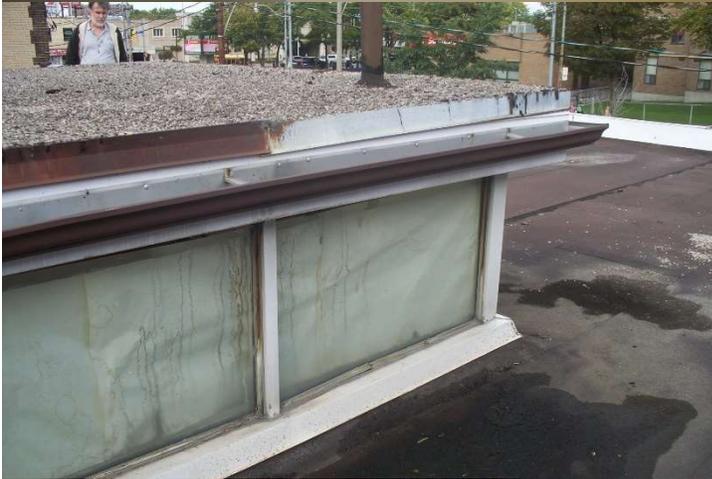
Photograph 53

Sample ID: ASB-10-19

Location: 276 Main Street, roof window frame

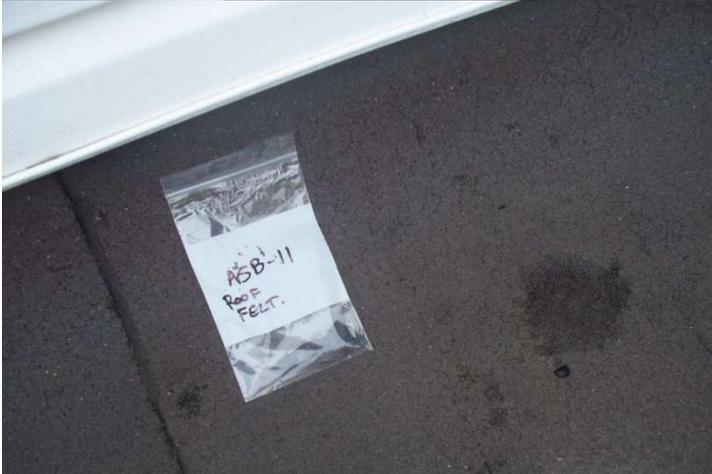
Photograph 53

Sample ID: ASB-11-19

Location: 276 Main Street, roof

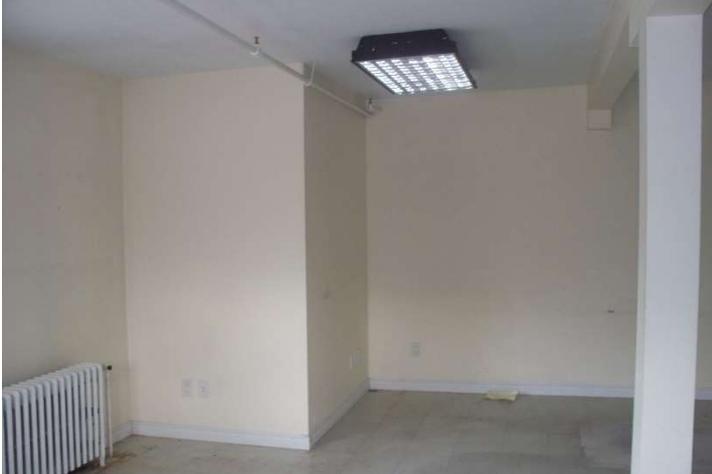
Sample ID: JC-14-19

Location: 276 Main Street, Suite 202
